## SITE CERTIFICATION SUMMARY

This Site Certification Summary provides information about the **Albany, Oregon, Site**. The U.S. Department of Energy Office of Legacy Management is responsible for long-term stewardship of the site under the **Formerly Utilized Sites Remedial Action Program**.

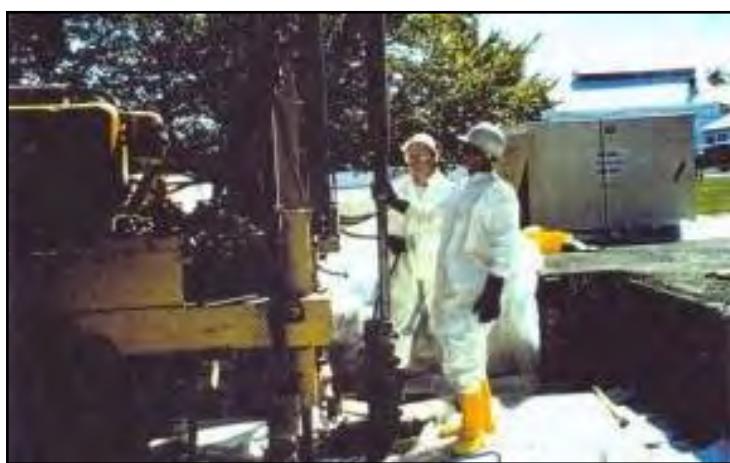
Radiological survey support work at the Albany, Oregon, Site, December 31, 1991 (DOE Digital Archive).
